## STABILIZATION OF LOWRY RUINS

ADRIAN S. WHITE  
AND  
DAVID A. BRETERNITZ

Mesa Verde Research Center  
University of Colorado  
Boulder, Colorado

March 1976

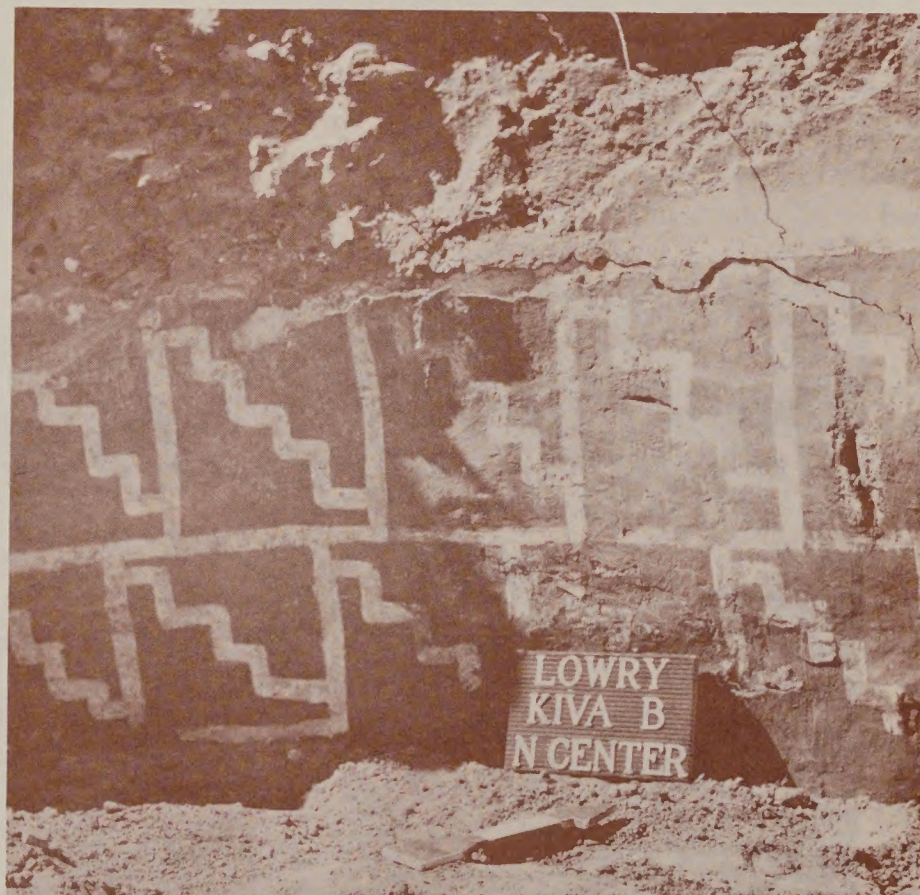
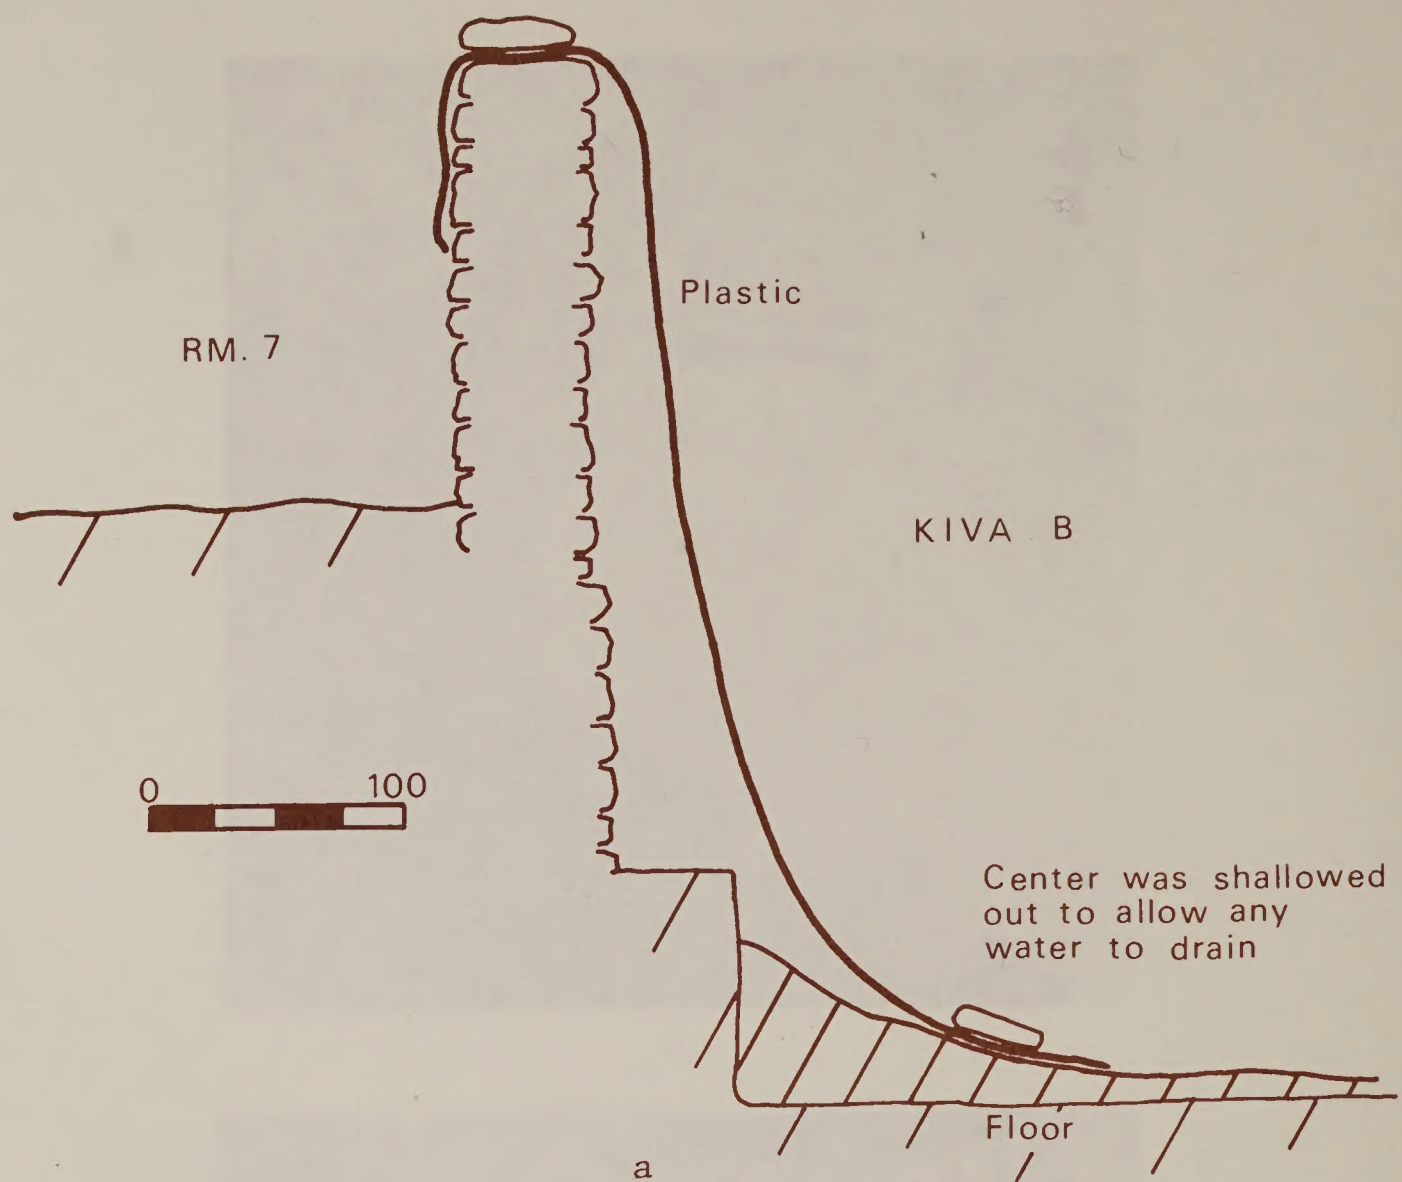
With the excavation of Kiva B the walls of Kiva A were almost completely removed, with only a small area remaining on the west side. Kiva B was excavated to 5-10cm above the floor. The benches were cleaned and the murals were photographed (Fig. 14). The condition of the murals was excellent in the areas that had not previously been excavated. Those areas that were lacquered showed damage primarily between the first and second pilasters. Painting the murals with shellac created a hard frontal surface which caused the plaster to separate from the stone wall and other layers of plaster. The presence of moisture, dirt, and roots behind these separated areas increased deterioration. When these areas were excavated, the plaster either crumbled or gradually began to break down as it dried out; no successful process has been discovered to stop this type of deterioration.

Figure 14. Kiva B. a, north view of murals after excavation in 1974; b, close-up of damaged area where plaster is peeling from the walls.

In order to recover as much of the design as possible, tracings were taken of the murals in sections. The tracings show what design remains, the areas cracked, and in some instances a previous design where the plaster had broken off. Close-up photographs were also taken of the entire bench (Fig. 15). A color sample was taken of the plaster. As soon as the murals were recorded, they were covered with strips of plastic sheeting, which were anchored to the tops of surrounding walls and draped down over the murals (Fig. 16).

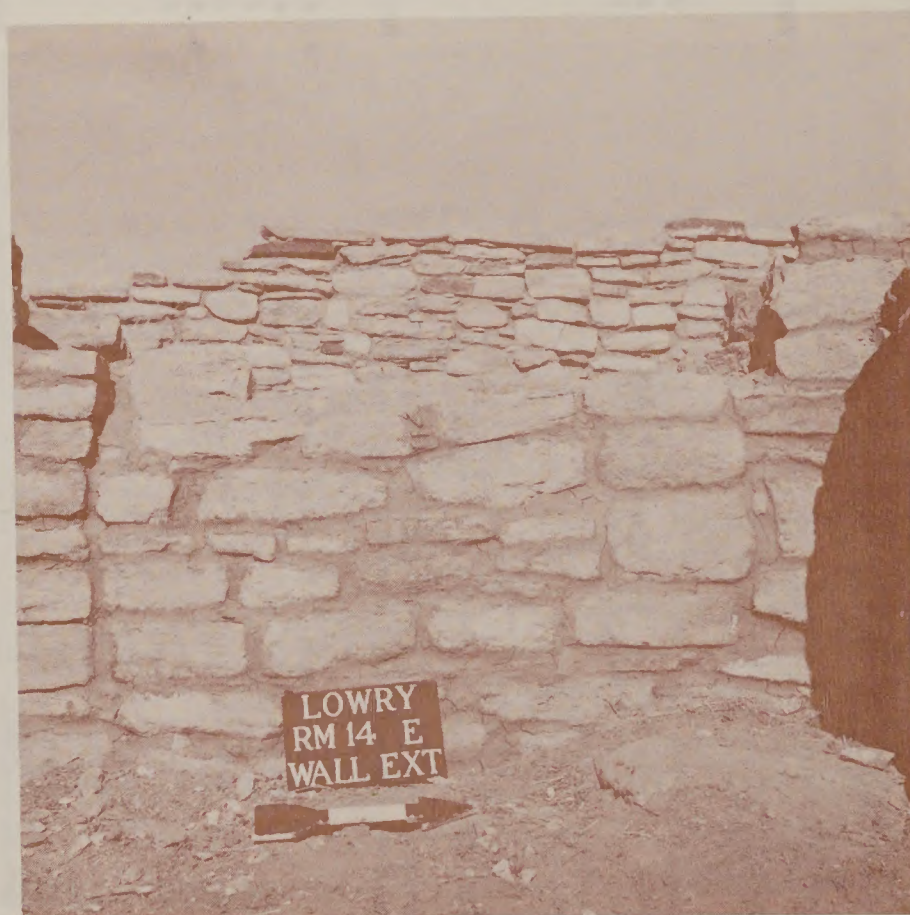
- A. The east exterior wall of Room 14 is capped on the upper 2 courses. The lower courses are composed of prehistoric masonry. Stones beneath the capped area are loose and the soil mortar is falling out and flaking off.
- B. No prehistoric masonry remains in the area of patch on the South wall of Rm. 18.

Figure 35. Room 14, east exterior wall. a, several stones were missing and large joints were created by crumbling mortar; wall was slumping at the abutment to Room 12; b, missing stones were replaced and the wall was straightened.

- A. East Ext. wall of Room 14 - all loose stones were removed and reset with a mixture of Portland cement and sand. The area reset was approx. 4-5 courses in height. Area was pointed with a soil mortar of 3 parts soil to 1 part sand.
- B. South Int. wall of Room 18 - several stones were reset with a mixture of Portland cement and sand.

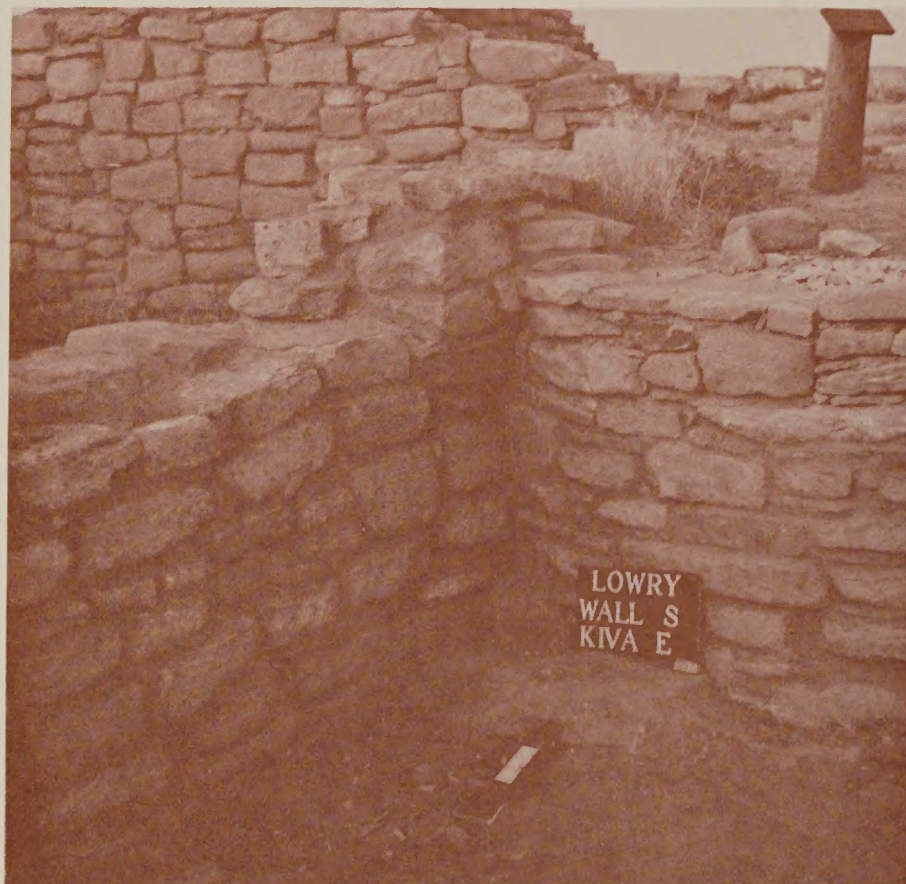
Figure 36. Kiva E, south exterior wall. A, several stones were missing and large joints were created by crumbling mortar; b, stones were reset and all large joints were filled.

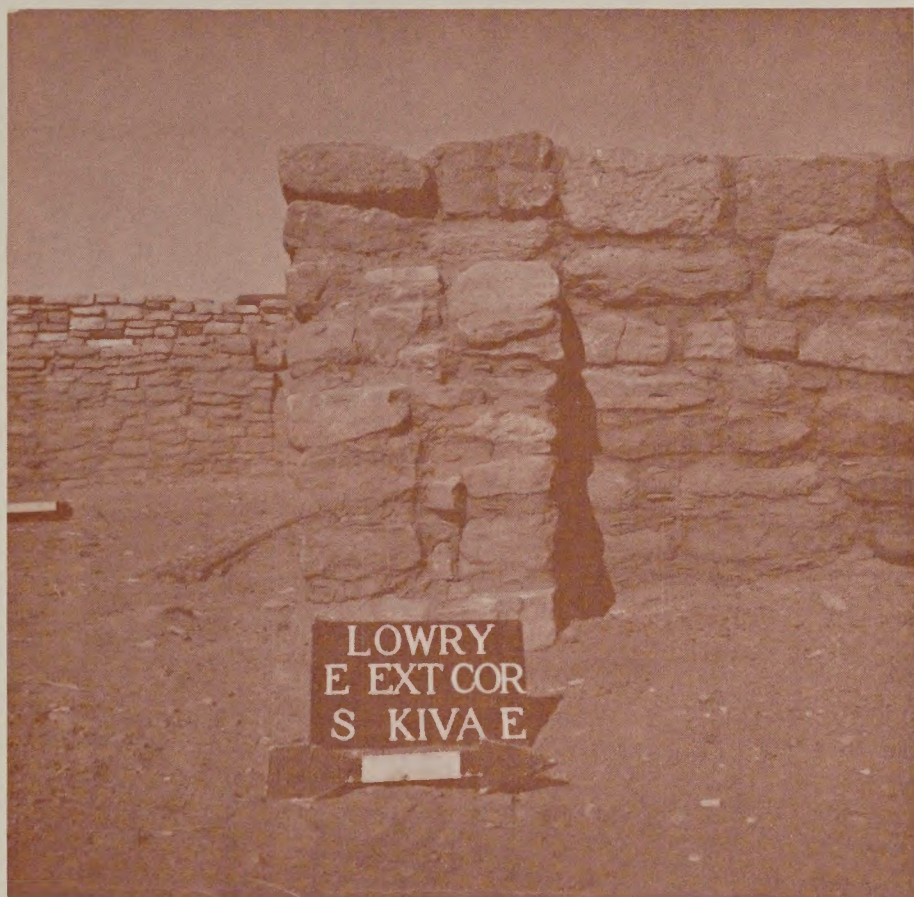
Figure 37. Kiva E, east exterior corner south of Kiva E.  
View after corner was stabilized. Several stones were reset  
and pointed with mortar.

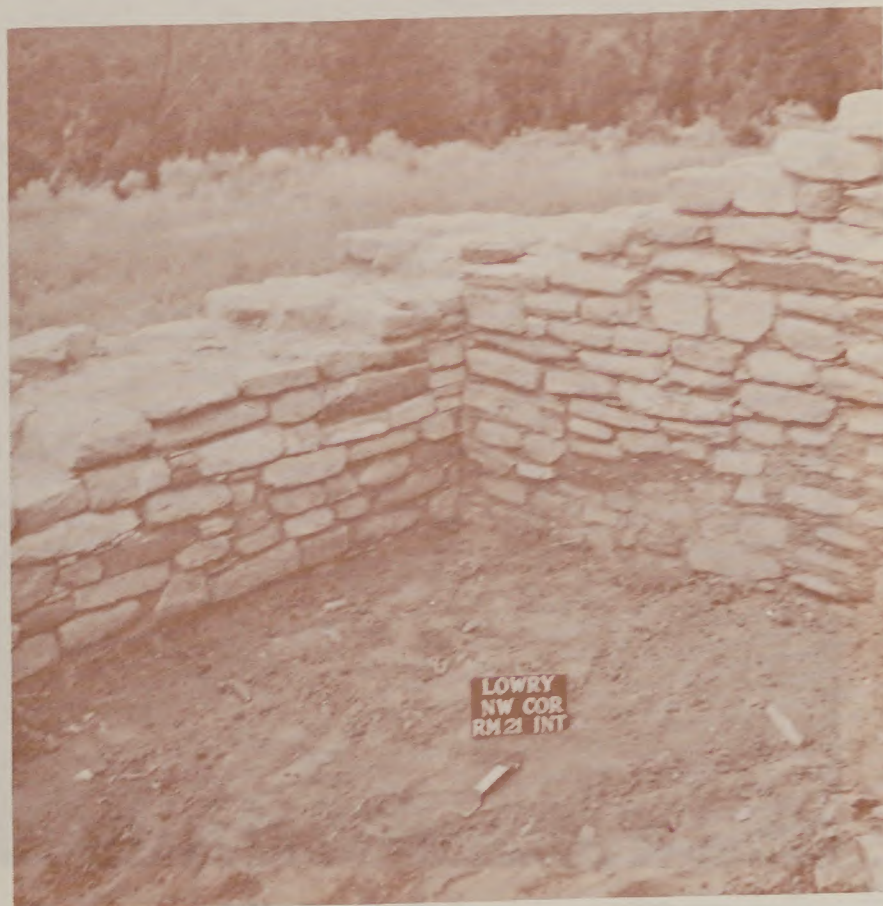
Figure 38. Room 21, northwest interior corner. a, large area of missing and fallen stones caused by undermining; b, stones were reset and pointed with soil mortar, soil was banked against the wall and sloped towards the center of the room.

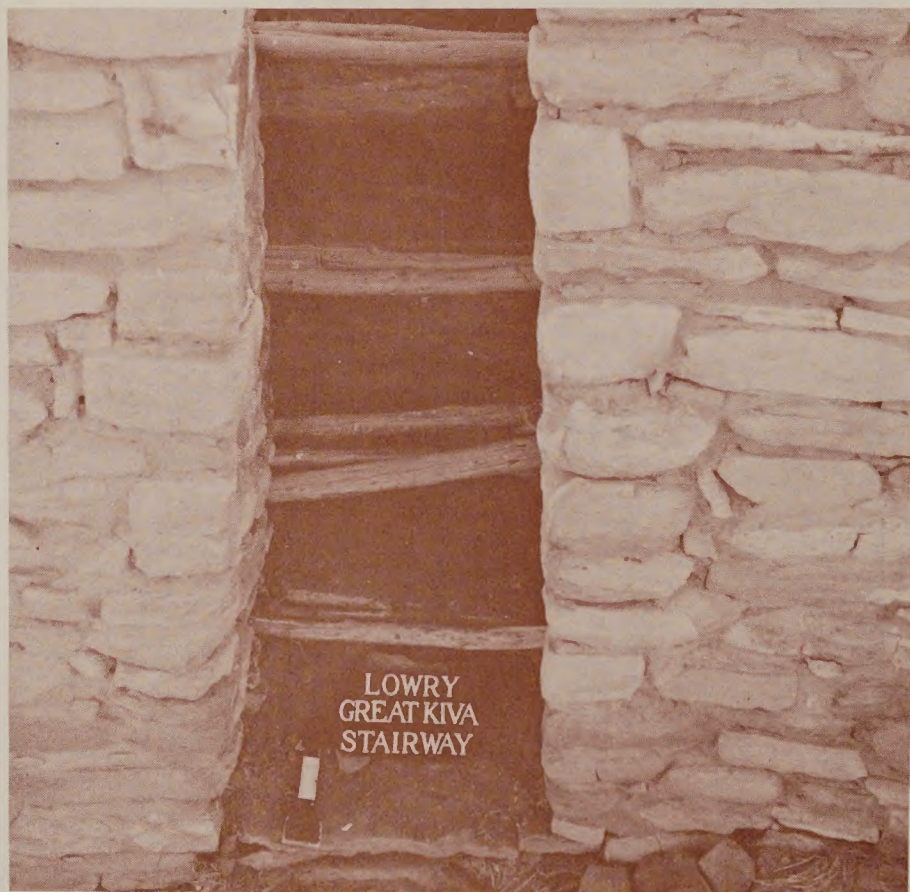
Figure 40. Great Kiva, stairway. a, stairway before stabilization in 1966; b, water runoff down stairway caused erosion behind wooden post steps.

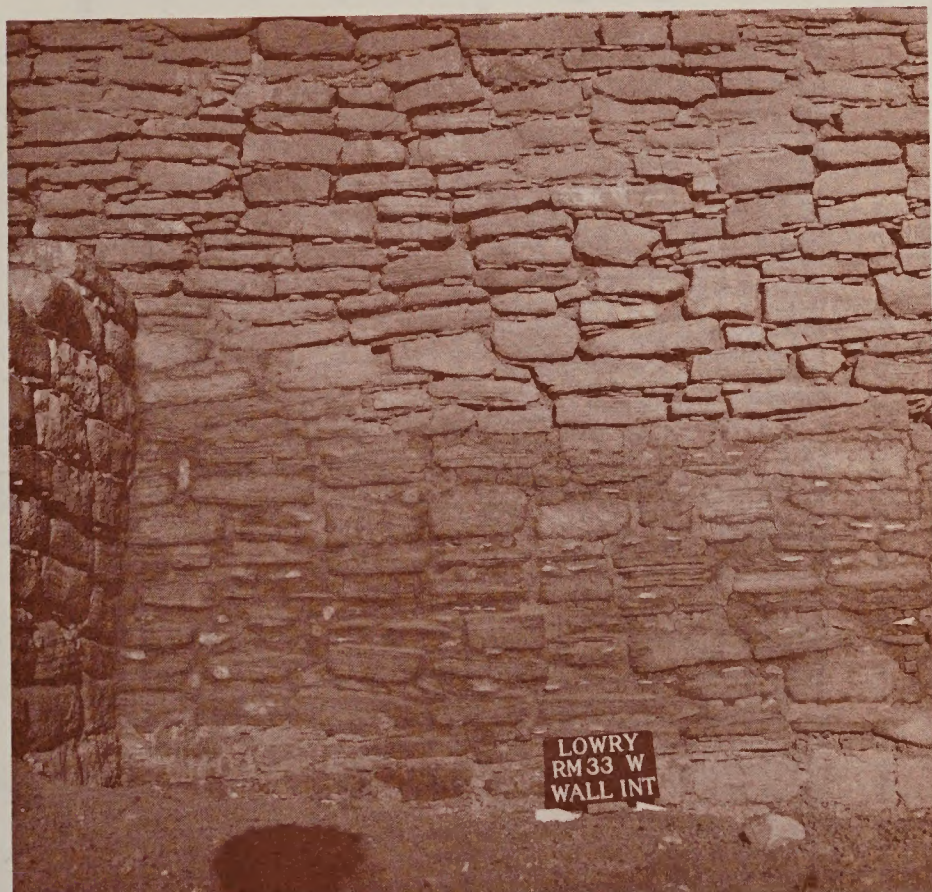
Figure 49. Room 33, north end of west interior wall. a, damage was confined to mortar crumbling from joints; excavation below ground surface showed no undermining of wall; b, soil mortar and spalls were replaced in the lower portion of the wall.

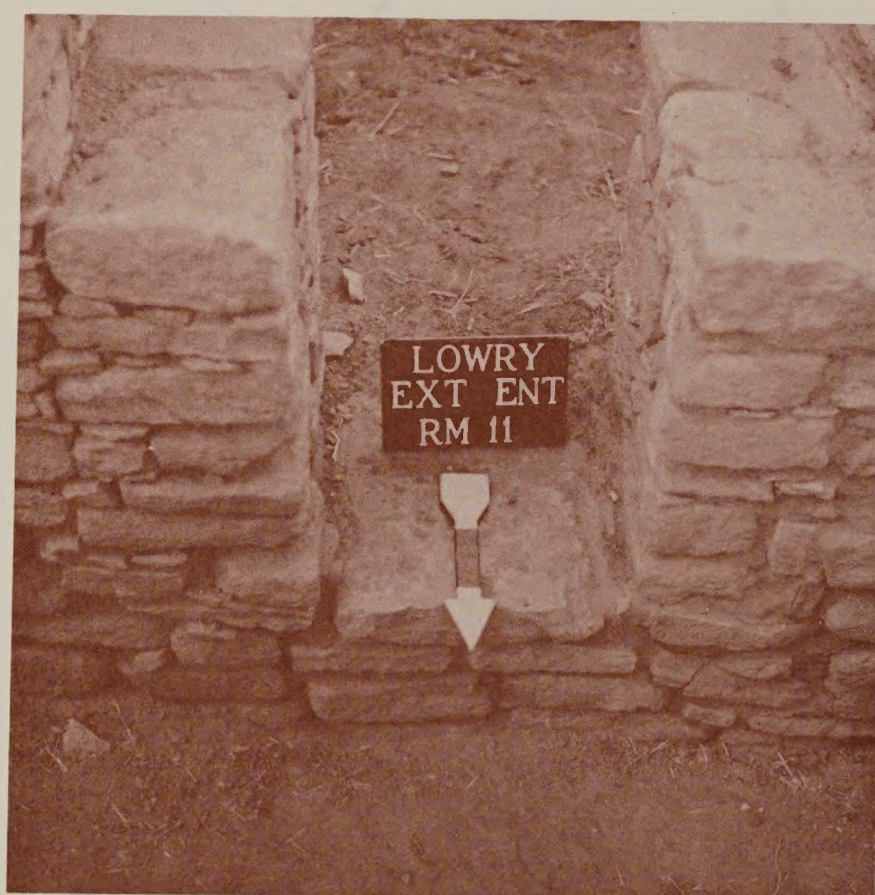
Figure 50. Room 11, north exterior entrance. a, step was loose, a stone was missing from the west side of the entrance and mortar was cracking from the joints; b, after stabilization.

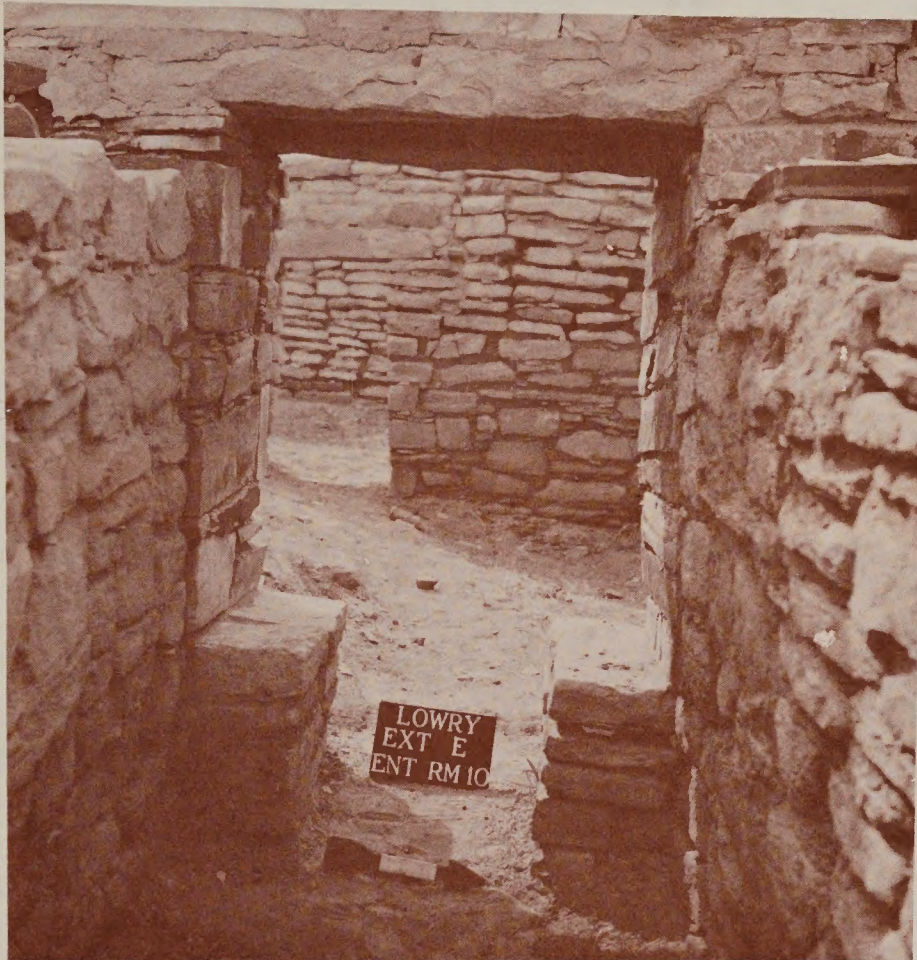
Figure 51. Room 10, exterior entrance. Several stones were replaced on the top course of the south bench of the T-doorway. No photo was taken before stabilization.

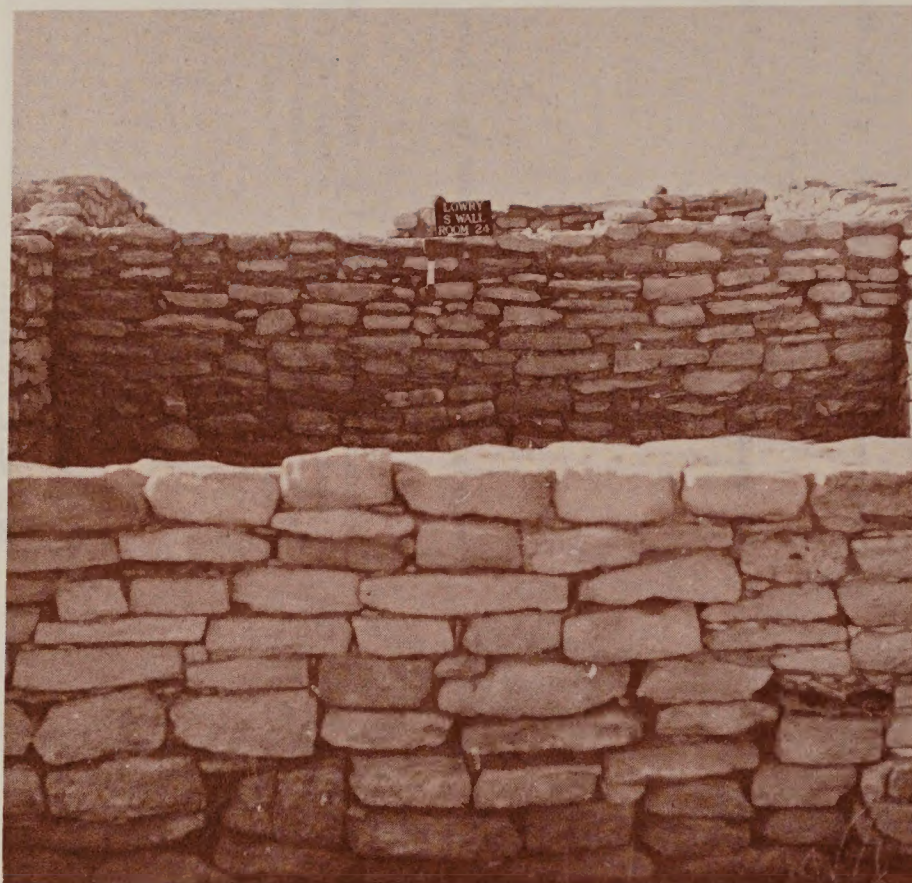
Figure 57. Room 24, south interior wall. Replaced 2-3 courses immediately below the cement cap. No photo was taken before stabilization.

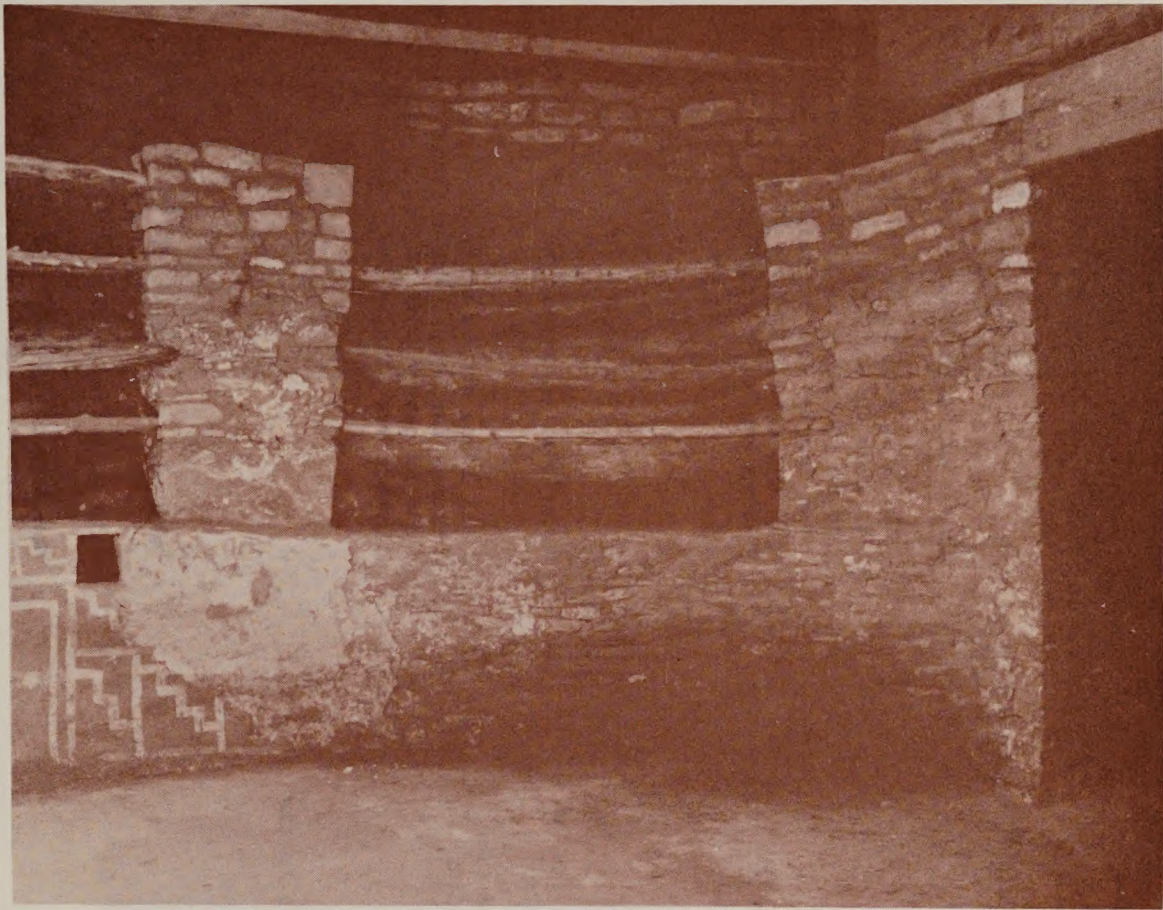
Figure 70. Kiva B, interior walls. Floor near the gate has been resurfaced and all newly cemented joints have been covered with soil mortar.

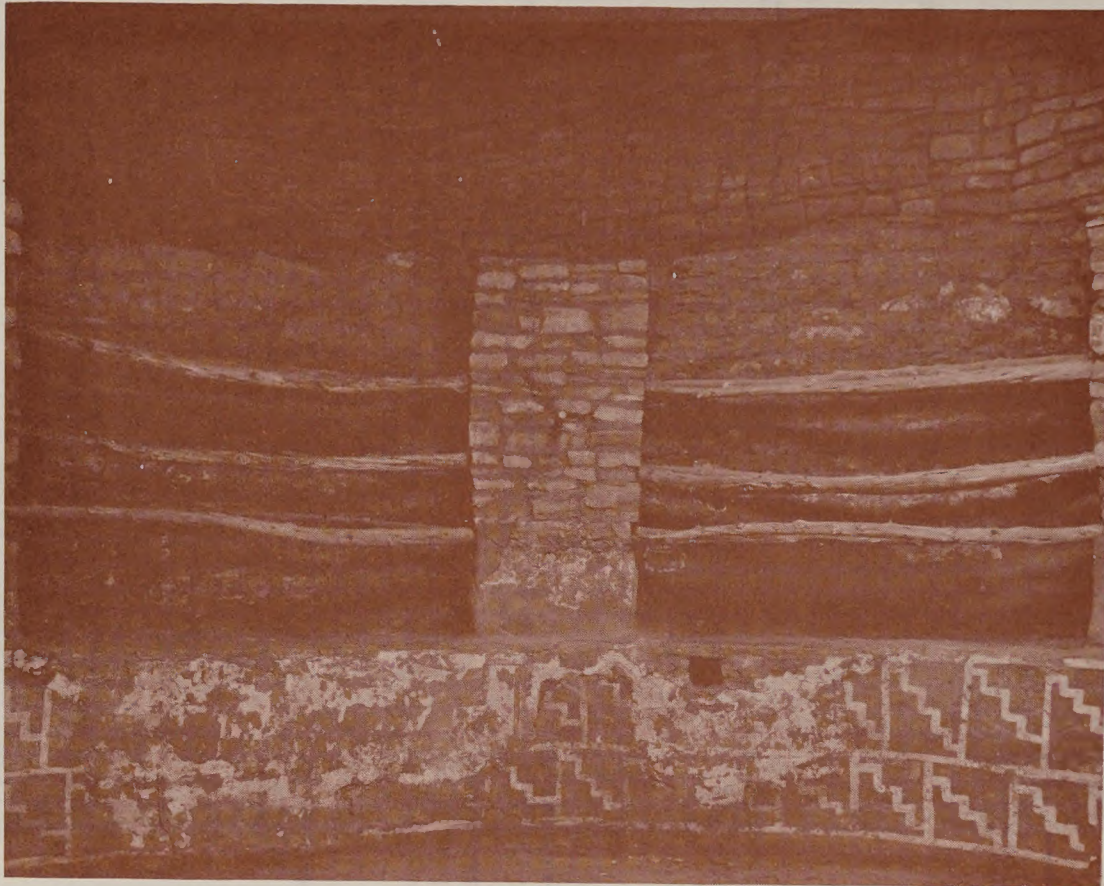
Figure 72. Kiva A, west wall. West view of wall after stabilization as retaining wall and as a foundation for roof.
